Manhole Inspection Summary

Manhole # S29GG1006MH

Insp Date: **7/16/08 8:35 AM**

Location Address: **3925 LINKWOOD RD**

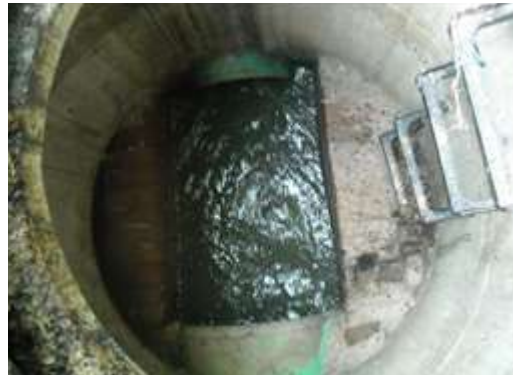
Top View

Bench ☒ Exists Material: **Brick** ☐ Parged ☒ **Debris** (not Condition related)

Surcharge ☒ **Evidence Of Surcharge** Depth: **1.5** (ft.) ☐ Active Surcharge Present

Evidence of surcharge - Bench debris.

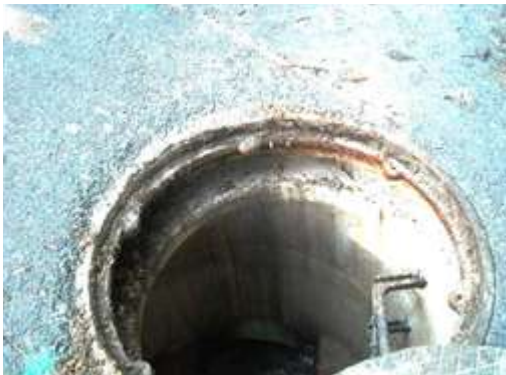
Defect

Frame Offset: **2** (in.) Condition: ☐ Sound ☐ Cracked ☒ **Leaks**

Infiltration: ☐ None ☒ **Joint** ☐ Cracks ☐ Mortar ☐ Roots ☐ Wall

Frame offset. Corbel infiltration.

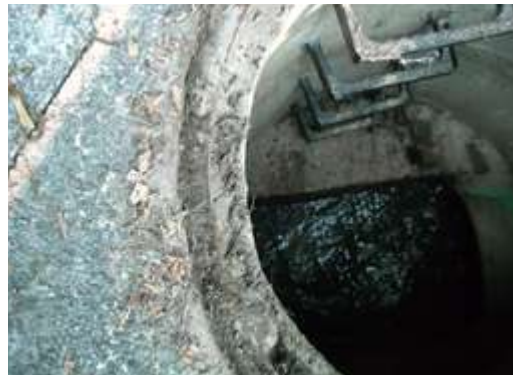
Defect

Frame offset.

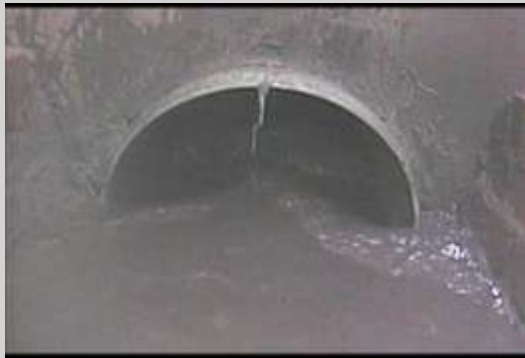
18 in. Circular Gravity Sewer Pipe Out @ 12 O'Clock

Invert Depth: **6.50** (ft.) Flow Characteristics: **Turbulent**

Infiltration: **None**

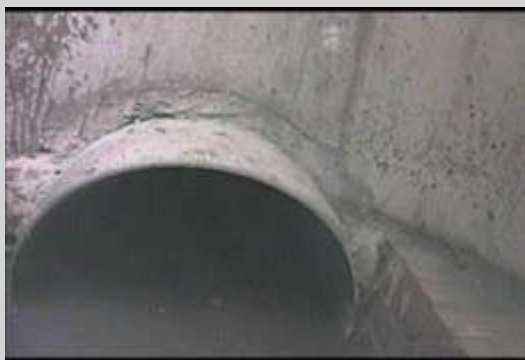
21 in. Circular Gravity Sewer Pipe In @ 6 O'Clock

Invert Depth: **6.30** (ft.) Flow Characteristics: **Fast**

Infiltration: **None**
